## Effect of Residual Chlorine on Copper Pipes in Drinking Water Systems

**Keywords:** Coupon tests; Corrosion; Disinfectant; Pipelines; Water quality.

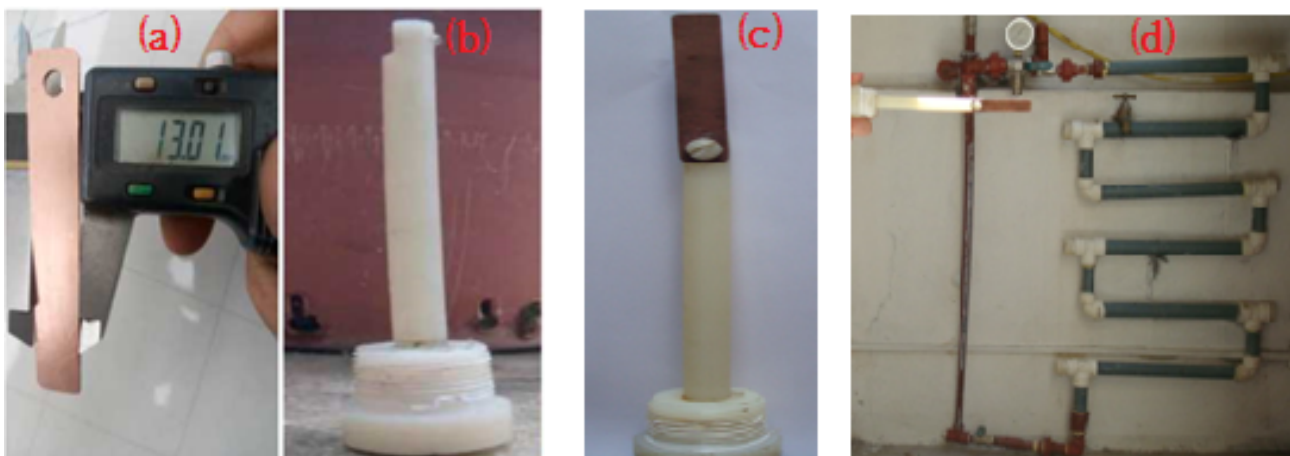
Fig. 1. (a) copper coupon, (b) coupon holder, (c) coupon holder with coupon, and (d) corrosion test racks

The corrosion surface coupons were prepared in accordance with ASTM G1-03 and NACE TM 0169-2000 (33). Copper coupons of 8-cm length, 1.2-cm width, 1-mm thickness and containing a 5-mm diameter hole for support, as shown in Fig. 1a. The coupon holder (Fig. 1b, Fig. 1c) was made from 1.25 cm diameter semi-crystalline polyamide materials and was 7.62 cm long to hold the coupon installed on the corrosion test rack. The corrosion test rack was used for the aforementioned test ii. The copper coupon was fastened by means of a nut and screws made of Grilon to avoid galvanic effects (ASTM, 2012) [47]. The corrosion test rack was made of PVC piping with horizontal sections of 40 cm and a vertical section of 10 cm (Fig. 1d). The test rack was installed directly to the distribution system in the house so the use of water was constant (Eisnor y Gagnon, 2003) [36].

Similarly, ten coupons were installed in corrosion coupon racks for a period of one, two, three and six months. Each coupon was weighed, placed in a coupon holder and then carefully installed in a corrosion test rack to ensure that water flowed from the coupon holder to the tip of the coupon. The coupons were oriented with the face wide in vertical position to avoid particle accumulation, which could accelerate corrosion (ASTM, 2005) [52]. Each test was performed in duplicate. At the end of the exposure period, the coupons were removed from the corrosion coupon rack, dried and cleaned following the chemical cleaning procedure described in Standard G1-03 (ASTM, 2003) [41]. A final weight measurement was taken and the corrosion rate in mils per year (mpy) was calculated using Equation 1.

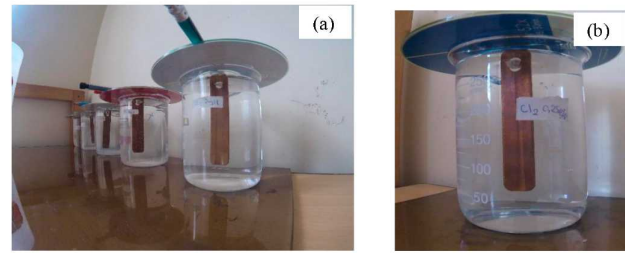
Fig. 2. (a) coupons submerged in 0.25, 0.5, 0.75, 1.0, 2.0, 5.0 mg/L chlorine solutions and (b) coupon immersed in 250 mL of solution

Calcium hypochlorite solutions were prepared in order to obtain residual chlorine concentrations of 0.25 mg/L, 0.5 mg/L, 0.75 mg/L, 1 mg/L, 2 mg/L and 5 mg/L (Fig. 2). Potable water was used for consistency [8]. Residual chlorine levels were measured using the HACH DR/890 colorimeter DPD method [53]. Chlorine solutions were prepared in 250 mL beakers, into which pre-weighed copper coupons were placed. The solutions were changed by using the emptying and filling protocol. Low concentrations solutions were changed every 48 and 72 hours [3] and high concentrations solutions were changed every 96 hours to represents the average stagnation period observed in various buildings, schools and offices [16]. This trial had a 30-day exposure time. The initial and final copper concentrations were measured at each solution change using an HACH DR/2500 Spectrophotometer [3].

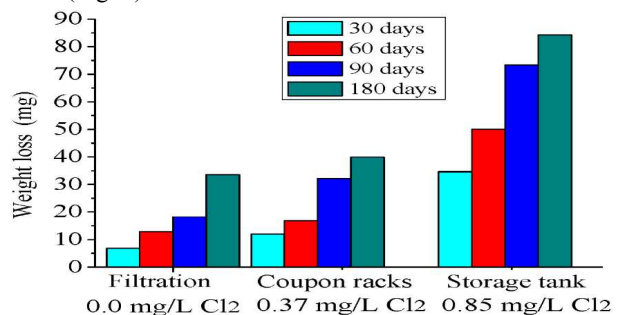
Fig. 3. Coupons weight loss in mg

The difference between the initial and final weight for each coupon at different exposure times is presented in Table 2; the weight variation was shown to have a direct relationship with the chlorine concentration for the different exposure times (Fig. 3).

Coupons tended to lose more weight when placed in water with higher chlorine concentrations. An analysis of

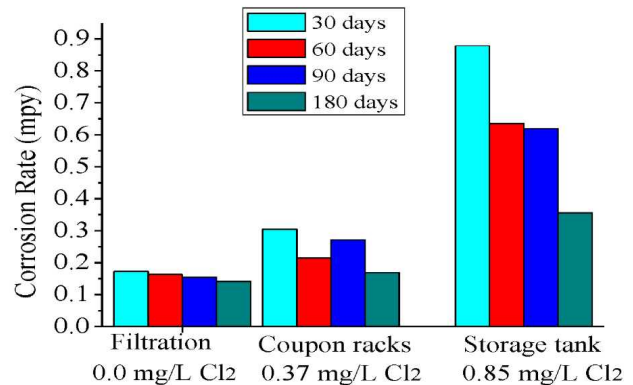
**Fig. 4.** Copper corrosion rate versus free chlorine concentration

As shown in Fig. 4, the corrosion rate for each exposure time was minimal at 0 mg/L of chlorine in water; in the storage tank, which has a Cl<sub>2</sub> concentration of 0.85 mg/L, the corrosion rate was higher. Thus, an increased chlorine concentration leads to an increase in the rate of corrosion. Additionally, the copper coupons experienced a higher corrosion rate in the first 30 days of exposure for all chlorine concentrations. As the exposure time increased, the corrosion rate decreased. Therefore, at a steady Cl<sub>2</sub> concentration, the corrosion rate decreases as the exposure time increases.

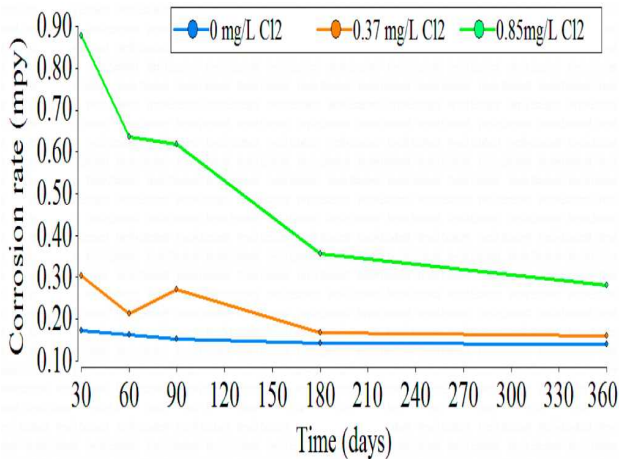
Fig. 5. Copper corrosion rate versus exposure time

The corrosion rate variation over time is shown in Fig. 5. At chlorine concentrations of 0 and 0.37 mg/L, the corrosion rate remained nearly constant after 180 days of exposure. As the exposure time increased, the corrosion rate became more constant; this can be attributed to the formation of a protective film on the material surface, giving rise to metal passivation. The passivation process has been related to the formation of a copper (I) oxide layer (Cu<sub>2</sub>O, cuprite) and another layer of copper (II) oxide (CuO, tenorite) [24, 30]. In spite of this, the corrosion continues, possibly because the formed film is non-adherent and conductive, allowing the passage of electrons.

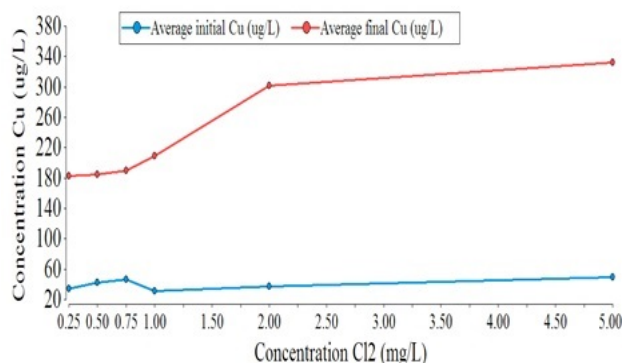
Fig. 6. Copper corrosion rate versus residual chlorine concentration

For chlorine concentrations between 0.25 to 5 mg/L in water, a considerable variation in the dissolved copper concentration occurred (Fig. 6). At chlorine concentrations of 2 mg/L and 5 mg/L, a greater copper release was generated. Chlorine concentrations between 0.3 to 0.7 mg/L are commonly found in the drinking water distribution network [45]; at this range, the copper concentration released is in the range of 180 to 220  $\mu\text{g/L}$ , which is within the dissolved copper limits recommended by WHO (2004) [60].

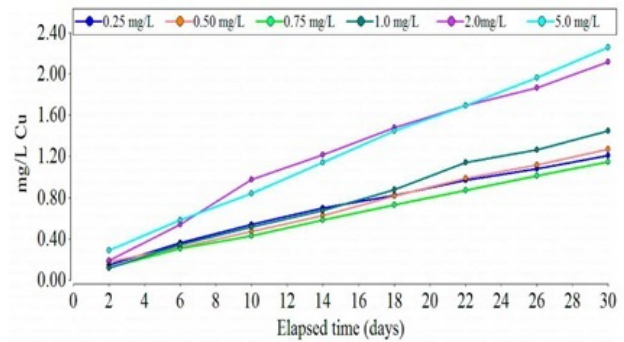
Fig. 7. Impact of residual chlorine on the cumulative concentration of copper released during the static immersion test.

Copper release trends were compared by summing the amount of copper (mg Cu/L) released during the entire exposure time (Fig. 7).

At a chlorine concentration of 5 mg/L, 2.31 mg Cu/L was released into water after 30 days. The increase in the cumulative copper release was rapid and almost linear throughout the trial. At lower chlorine concentrations, between 0.25 and 0.75 mg/L, a lower amount of copper was released.

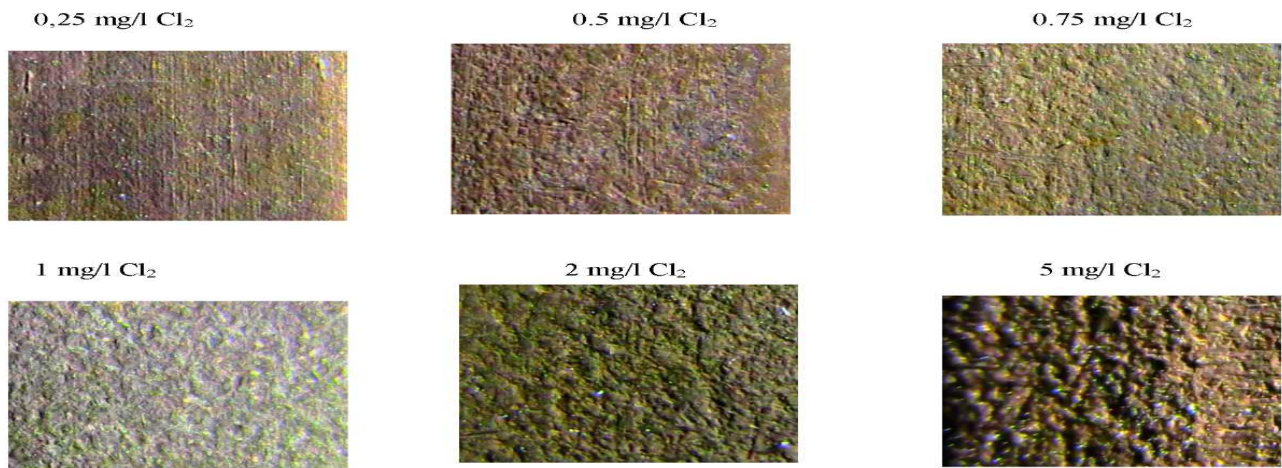
Fig. 8. Visual examination of the surface of the copper coupons after the static immersion test for each chlorine concentration

Samples aged with calcium hypochlorite concentrations of 1, 2 and 5 mg/L showed greater pitting corrosion after 30 days of exposure, while samples aged with 0.25, 0.5 and 0.75 mg/L showed less pitting corrosion, wells are observed on the exposed surface (Fig. 8). As mentioned by Castillo Montes et al. (2014) [8], an incubation period in the residual chlorine presence is needed to detect pitting corrosion in the copper pipe.

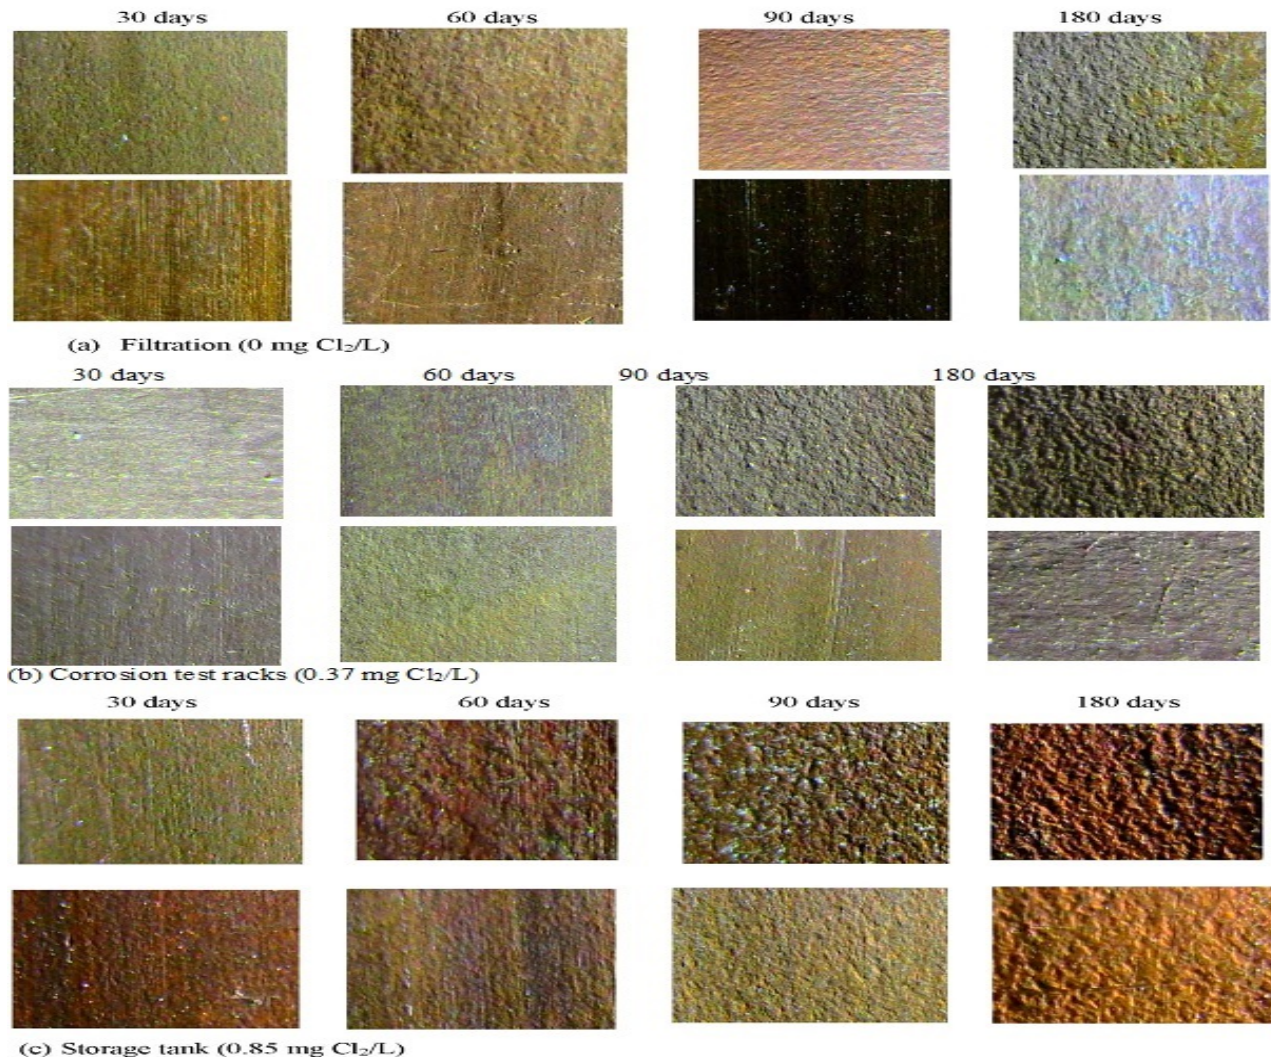
Fig. 9. Image of corrosion of the copper coupons

A visual examination showed holes and discoloration in the coupons at the end of the tests. Fig. 9 shows the copper metallography at different immersion times (a) under filtration (b) in a storage tank and (c) in corrosion test racks. Fig. 9 (a) shows a change in the coloration in certain areas of the coupons; this may be due to corrosion by the chlorine. An uneven layer of tenorite was observed on the surface of the pipes exposed to filtered water without chlorine. Signs of pitting corrosion were observed. At 180 days, the surface of the copper was coated with a relatively uniform light blue layer. Fig. 9 (b) shows a dark coloration, typical of a copper oxide such as  $\text{Cu}_2\text{O}$  [16]. The impact of chlorine on the surface is evident. Coupons exposed to the higher chlorine concentration in the storage tanks contained deeper cracks in those in corrosion test racks did. At a chlorine concentration of 0.37 mg/L, a dark brown layer was observed that covered the plate (Fig. 9b). This thin layer can be copper oxide (tenorite), which is related to the process of passivation of the corrosive process.

In Fig. 9 (c), the copper coupons were covered with brown corrosion products. After 180 days of exposure to a chlorine concentration of 0.85 mg/L, localised degradation in the form of circular pits were observed. The surface of the coupons was covered with brown corrosion products and a few shallow and wide wells were observed at 90 and 180 days. Green corrosion products were visible at the bottom of the wells. Calcium hypochlorite may also influence copper deterioration, as previously suggested by Castillo Montes et al. (2014) [8].
